PHOTOGRAPHIC INTELLIGENCE REPORT

VITAL RECORDS COPY
INDUSTRIAL ACTIVITY

NORTH VIETNAM

CIA/PIR75103

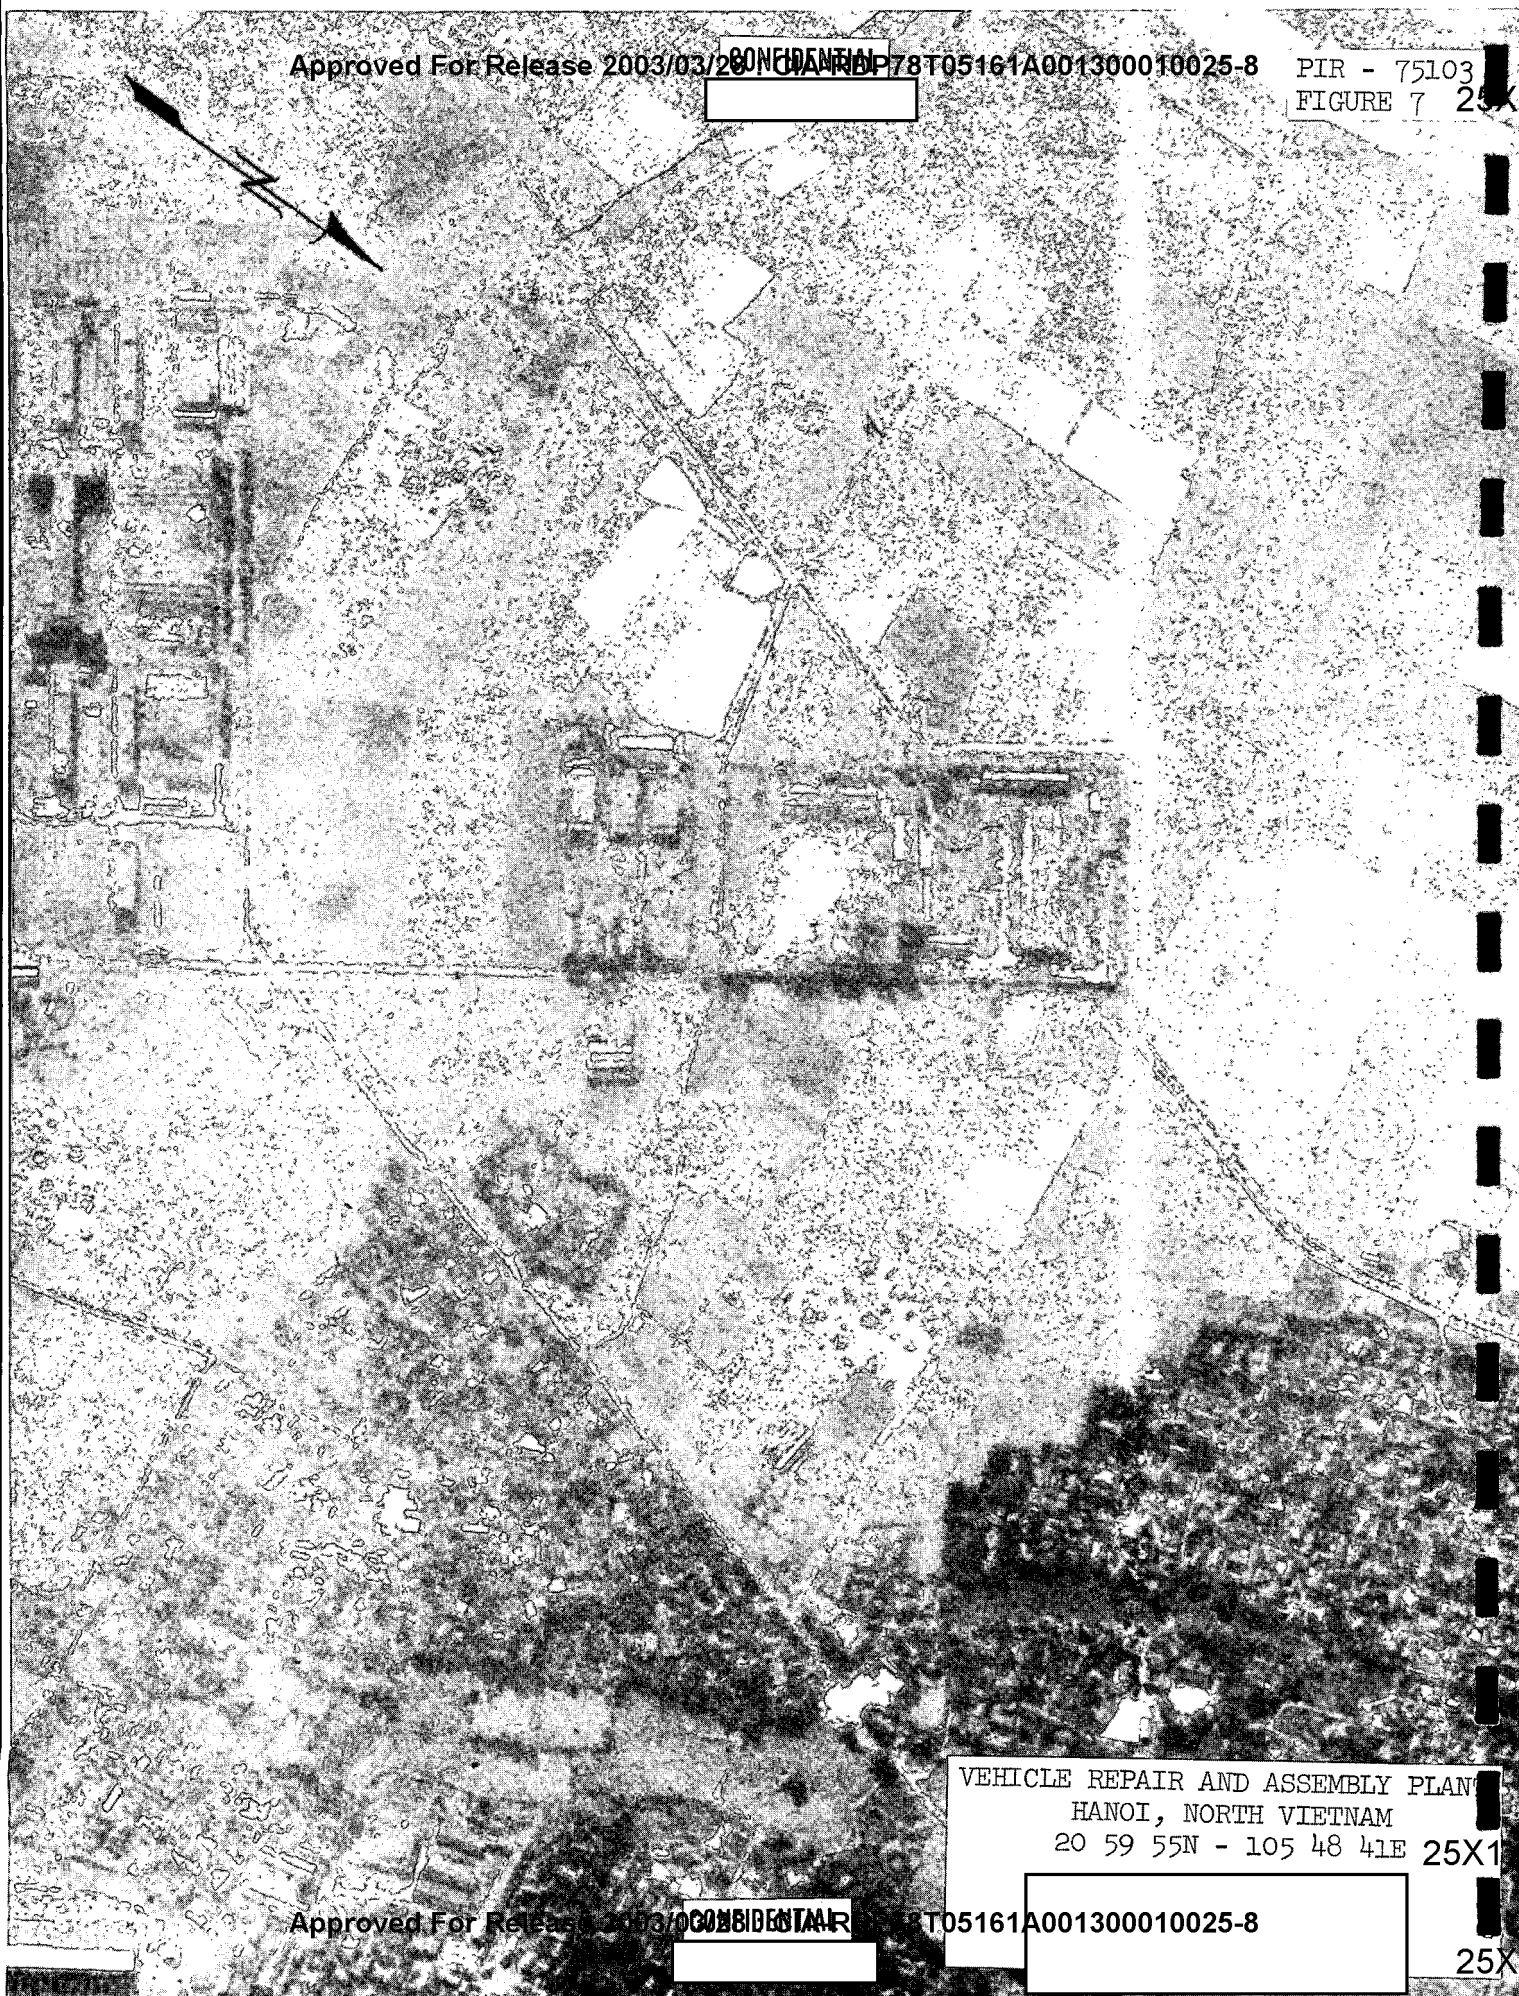
Photography of [] shows that construction in the plant area continues. The small building and adjacent storage tank in the northern section of the plant appears to be completed. One of the large buildings in the southeastern section of the plant has been removed. Recent photography of good quality suggests that the previously reported new access road into the plant is a roadbed for three rail spurs. The latest photography dated [] (Figure 6) shows a second building under construction in the northern section of the plant.

PROBABLE RAILROAD SPUR U/C

BUILDING REMOVED

AREA OF CONSTRUCTION

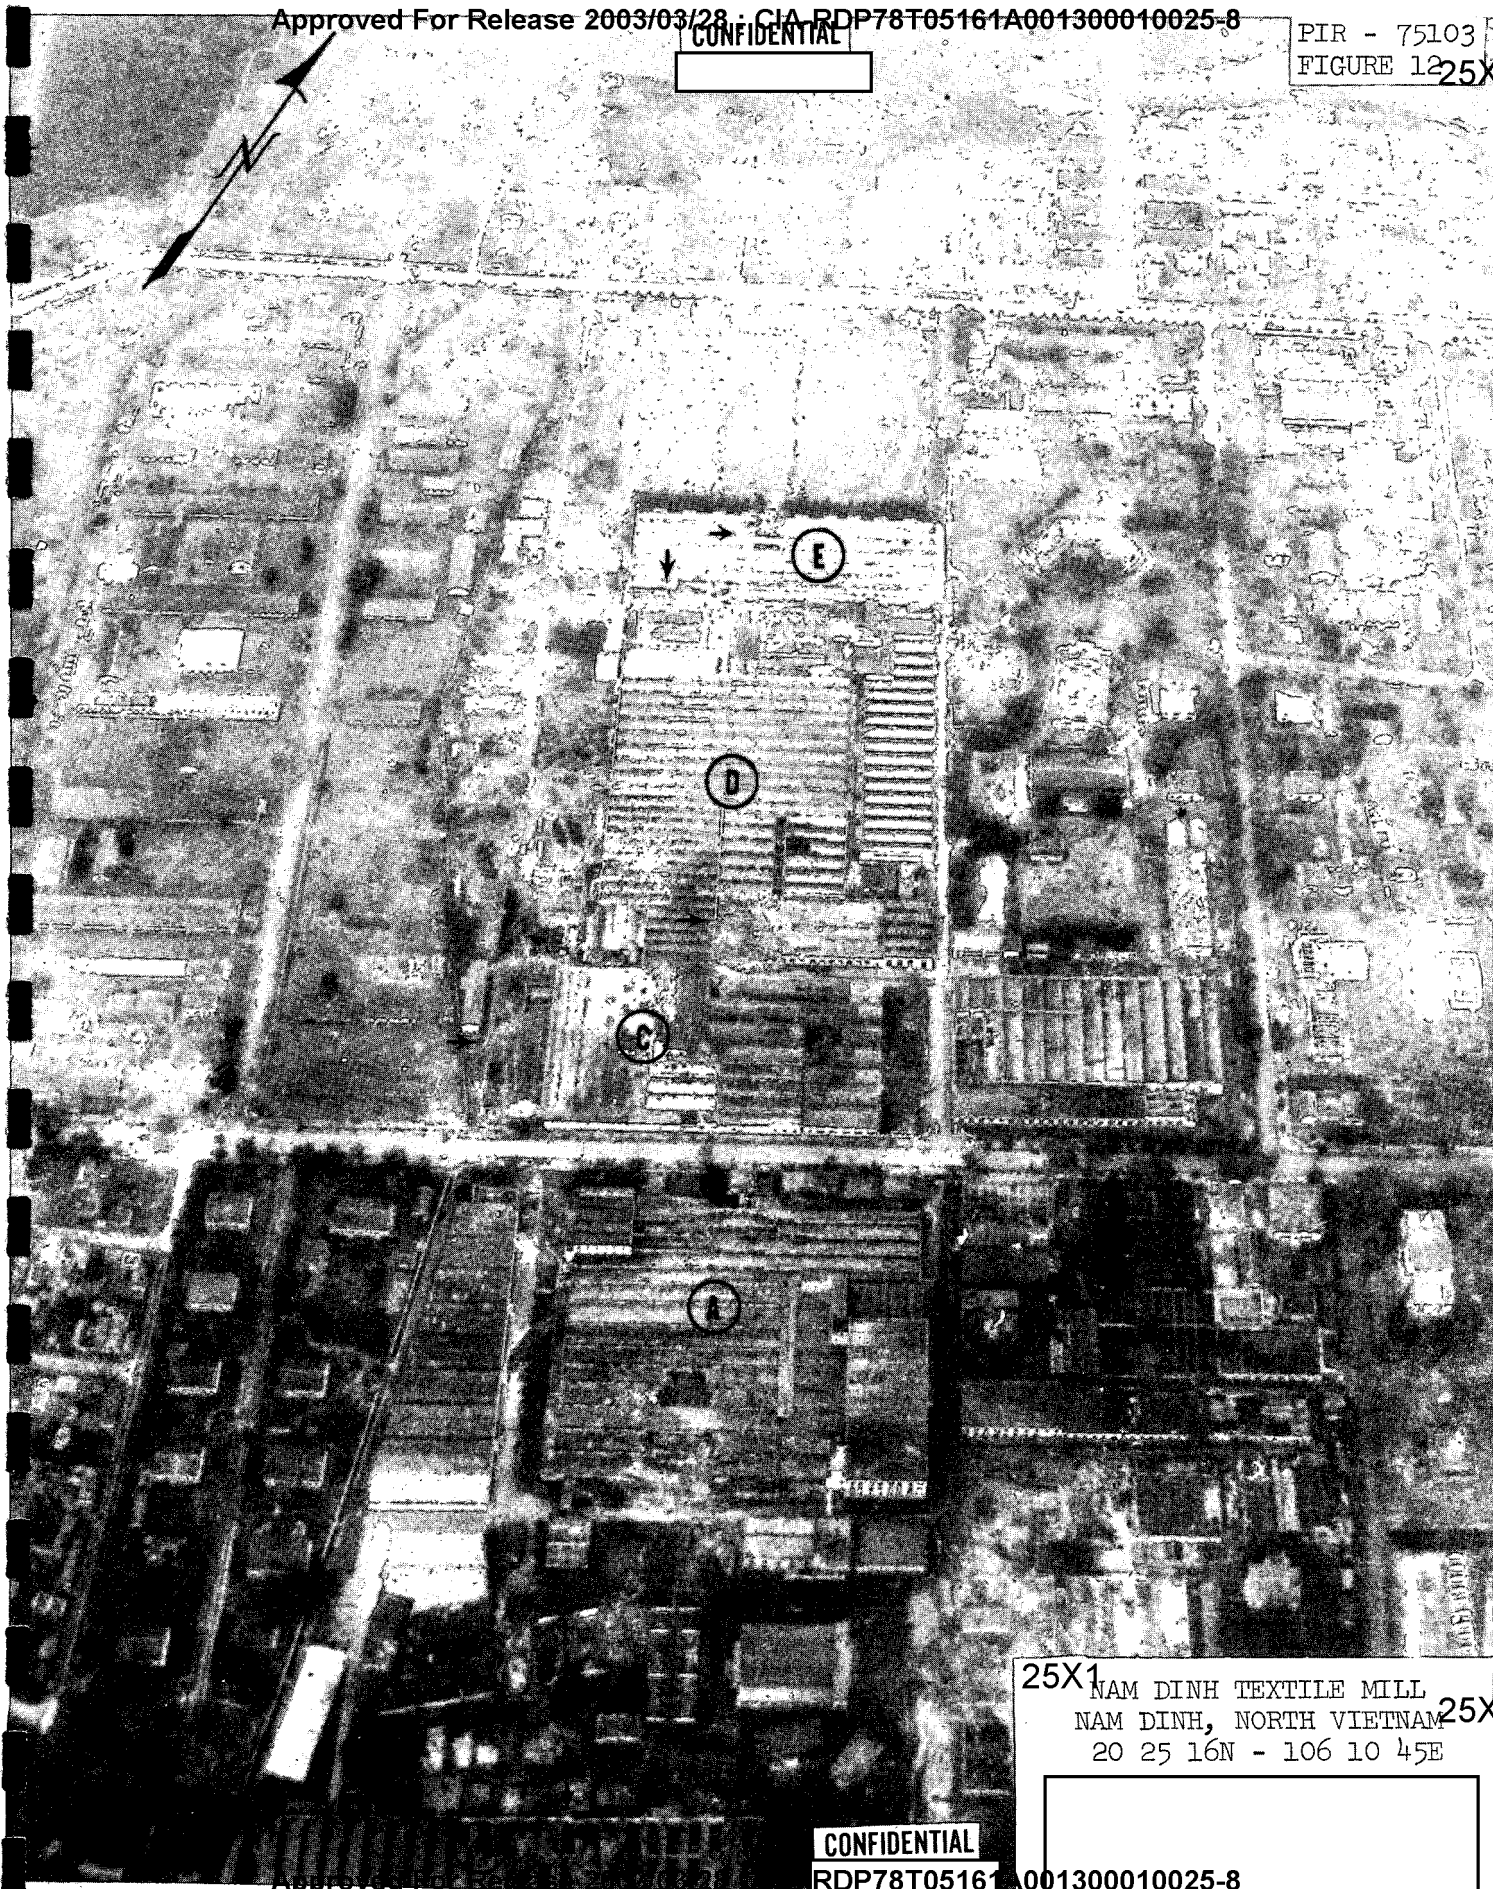
PIR - 75103
FIGURE 12 25X1

A study of recent photography dated [REDACTED] (Figure 12) shows additional damage to the main production buildings (B, C, D, E) and various support structures. This damage varies from superficial to extreme structural.

There is no apparent activity within the plant area and the debris appears to remain on the building floors.

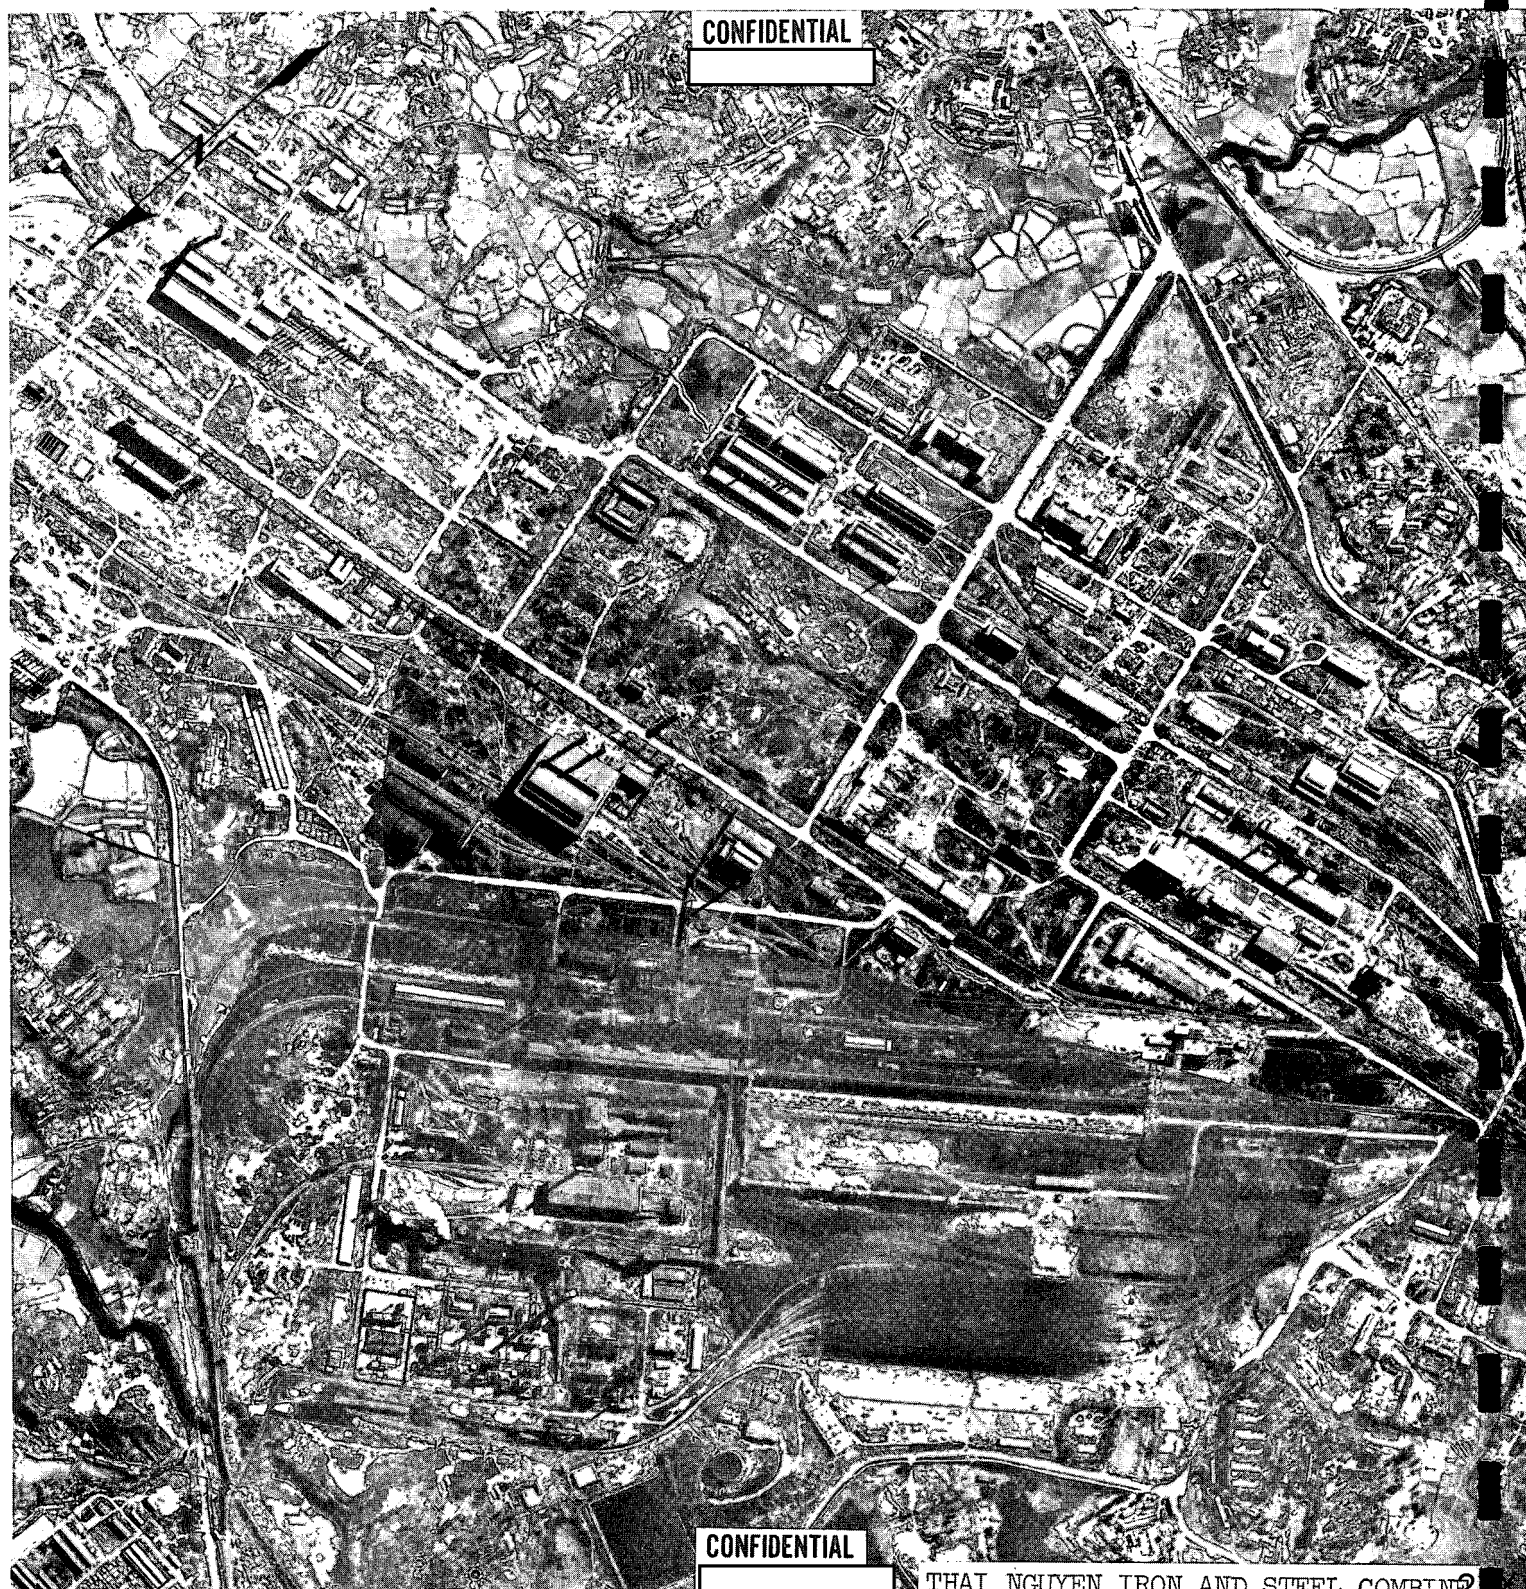
THAI NGUYEN IRON AND STEEL COMBIN²
THAI NGUYEN, NORTH VIETNAM
21 34N - 105 52E

Analysis of this facility was accomplished from photography of [REDACTED] The study revealed that all three blast furnaces were apparently operational [REDACTED] but only two were active on [REDACTED] The latest coverage (Figure 13) reveals that all three of the blast furnaces are operating and that the plant is capable of producing iron but not steel.

Quantities of raw materials appeared to be approximately the same on all missions. More than 82 pieces of rolling stock, including two engines, were counted on the [REDACTED]; no rolling stock count could be made on the [REDACTED] Approximately 20 pieces of rolling stock were counted on the [REDACTED]
